Lake Kate Sheppard:

An exemplar mahinga kai site?

GEO 402  
Urban Development  
Ada Zhang  
Steve Carrick  
June 2014

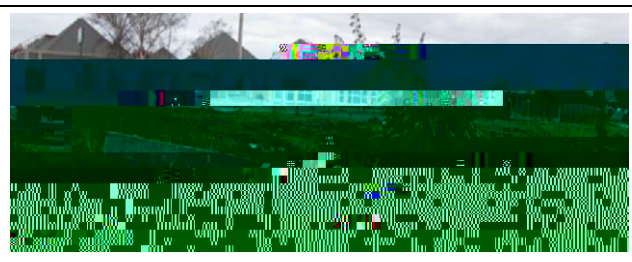
The seismic events of 2010 and 2011 also had major effects on the structure of the banks and the shoreline plantings. The liquefaction not only placed significant amounts of silt through the plants but also damaged large areas of plants. A comparison of the shoreline for pre and post seismic events can be seen in Figures 15 and 16. Remedial action needs to be completed to replace/restore the shoreline planting to provide a suitable habitat for inanga to lay their eggs. This needs to cater for a mean water level and the plants chosen require some resilience for the fluctuating water level from high water events, tidal surges and flooding as well as low water events. Planting should also incorporate plants to reduce the impact of Canadian geese and the residue that they create as this can be prolific and further reduce water quality.

Fig 16. Shoreline post earthquake
