Executive Summary

This research examines the current physical condition of the Sumner and Richmond Hill Streams in the Sumner catchment of Christchurch, how other urban waterways have been restored and evaluates

Habitat Sumner is a community-based group interested in the recovery of environmental assets to meet the needs of the Sumner community in Christchurch. This research aims to examine the physical characteristics of the highly modified Sumner and Richmond Hi

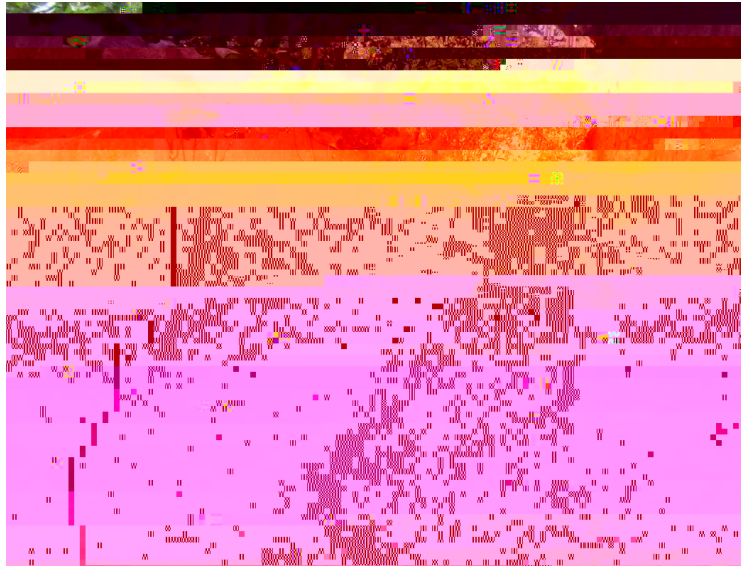
Figure 4: Sumner Stream at Scarborough Beach: Highly modified in box culvert.

3. Scarborough Beach Site, Sumner Stream

Stage One, Low Impact

Box culvert removed on park side

Native riparian zone, instream vegetation

Placing natural coarse substrate in the streambed

Redevelopment of the Scarborough beach site is complex due to the riparian zone being constricted, not only by the concrete culvert but by the road and toilet block located directly either side of the channel. As an initial low impact measure, it is recommended that the box culvert be removed on the park and toilet side and to create a natural sloping bank in its place. This will open the space up as a resource for the park rather than concealing it. Once again, native vegetation should be planted and natural substrate be added to the bed to increase the potential for habitat.

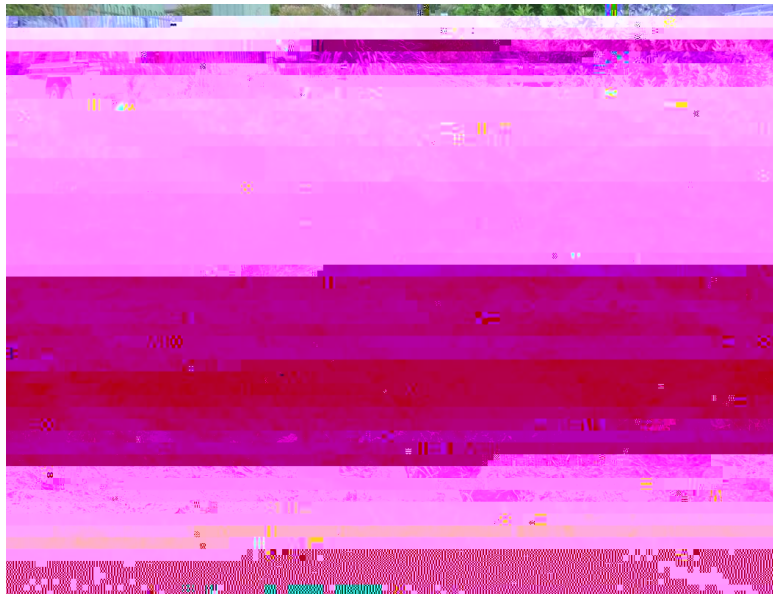
Figure 5: Richmond Hill Stream at restored site with daylighting. (Only one measurement site was
