TREES FOR CANTERBURY

What is an optimal native-plant regeneration strategy which fits the drainage flow for Marley Hill and 'Flying Nun' mountain bike track?

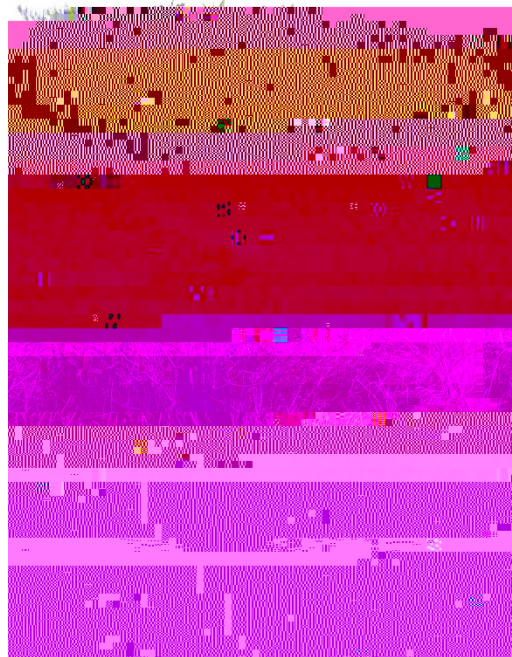
Figure A.1: An example of native regeneration which is struggling because of drainage flowing at its base. (a) is an example of a healthy native plant species, this photo was taken

determine the direction that ecological restoration processes take. This can be witnessed by regeneration efforts on Marley Hill as Trees for Canterbury and CCC operate to restore land use activities from economic driven agriculture back to a regenerated natural ecosystem. Thurston and Reader (2001) concluded that in relatively short-term time scales (years) effects on soil and forest habitat would be impacted greatest by mountain biking and other recreational activity. Because of this recreational impact it is of great importance that any regeneration efforts made are planned effectively for optimal survival of plants. This not only benefits the natural ecosystem, but maximises Trees for Canterbury's investment and involvement in native regeneration. Trees for Canterbury and the CCC have been investing time in the Marley Hill recreational area prior to approaching the University with an opportunity. It had been noticed that the same species of native plants were experiencing different growth rates and survival potential within close proximity to each other, as seen in Figure A.1, Appendix A.

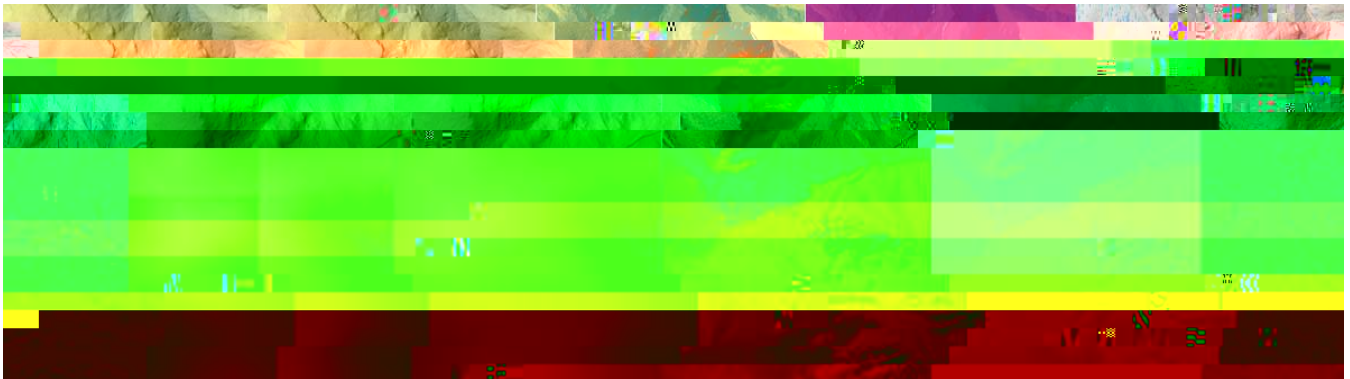
Figure D.1: Visual representation of creation of GIS drainage modelling

direction. Finally, a stream order tool was used to infer a drainage network (these steps are visually shown in Figure D.1, Appendix D and described in a flow chart Figure D.2, Appendix D). Stream ordering is a method of assigning numeric order to a network by identifying and classifying types of streams based on a numeric threshold. For example, first order streams are dominated by overland or surface water flow and do not have any contributory flow from above streams.

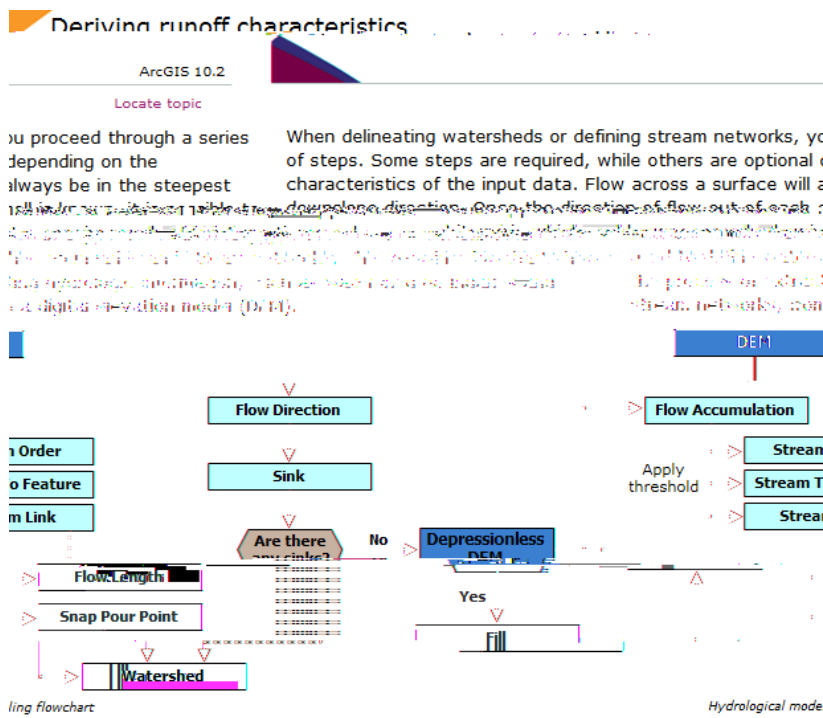
Figure D.2: Flowchart of steps taken in GIS drainage modelling
